# Manhole Inspection Summary

Manhole # S47II\_051MH

Insp Date: **5/2/08 9:34 AM**

**Location** Address: **Collington Ave**

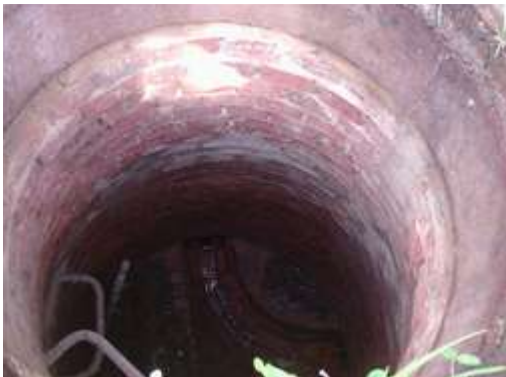
Defect 2

**Frame** Offset: **0** (in.) Condition: ☐ Sound ☐ Cracked ☒ **Leaks**

Frame Leaks

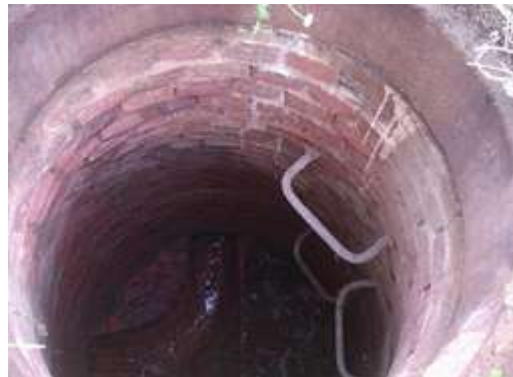
Defect 1

Condition: ☐ Sound ☐ Cracked ☐ Root Intrusion ☒ **Loose Brick** ☐ Deteriorated

Loose Bricks

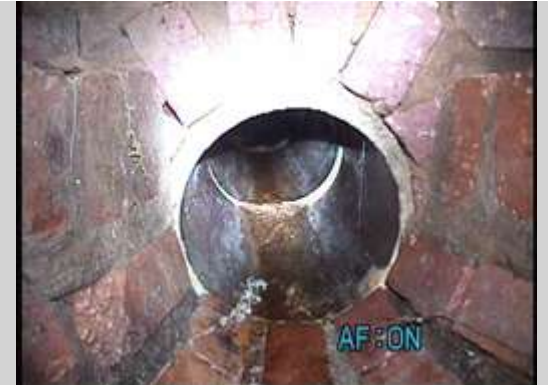
12 O'Clock Outflow

Pipe Height: **8.4** (in.) Rod and Bar (Angled)  
Pipe Material: **Clay** ☐ Pipe Lined  
Invert Depth: **9.25** (ft.) Flow Characteristics: **Fast**  
Deposits: ☒ None ☐ Mud ☐ Sludge ☐ Debris ☐ Grease  
Silt Depth: (in.) Deposits Extent:  
Infiltration: **None** Pipe Seal Cond: **Sound**

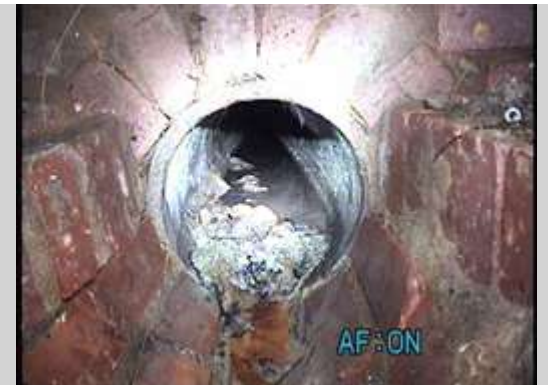
3 O'Clock Inflow

Pipe Height: **8.4** (in.) Rod and Bar (Angled)  
Pipe Material: **Clay** ☐ Pipe Lined  
Invert Depth: **8.80** (ft.) Flow Characteristics: **Slow**  
Deposits: ☐ None ☐ Mud ☐ Sludge ☒ **Debris** ☐ Grease  
Silt Depth: **2** (in.) Deposits Extent: **Light**  
Infiltration: **None** Pipe Seal Cond: **Sound**

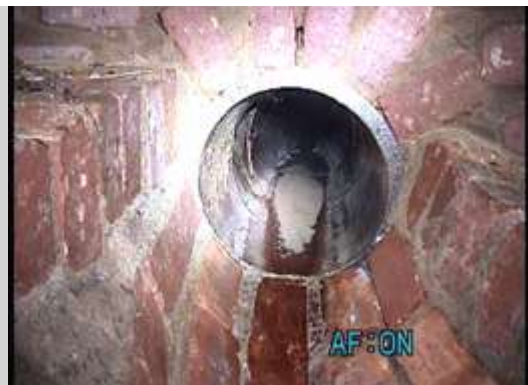
9 O'Clock Inflow

Pipe Height: **8.4** (in.) Rod and Bar (Angled)

Deposits: ☒ None ☐ Mud ☐ Sludge ☐ Debris ☐ Grease

Infiltration: **None** Pipe Seal Cond: **Sound**
